J-5781

CSD/NPIC 349/64  
25 November 1964  
Page 1 of 3  
Copy 2 of 8

ROUTE 9 BY-PASS  
MUONG PHINE AREA, LAOS  
1634N 10554E

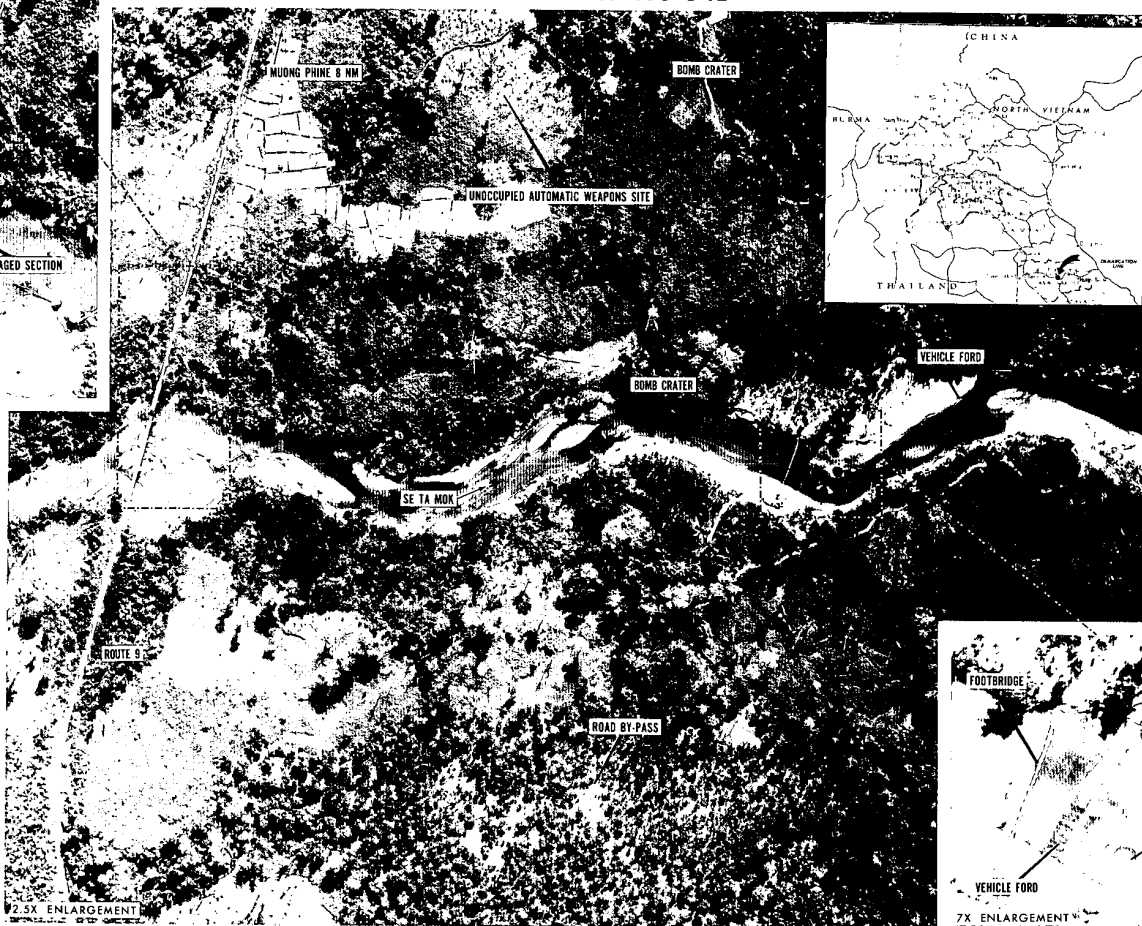
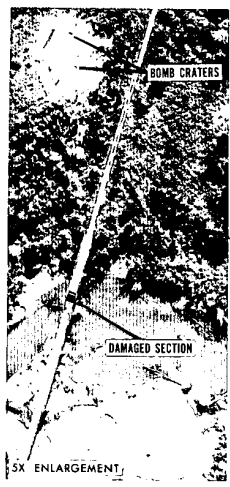
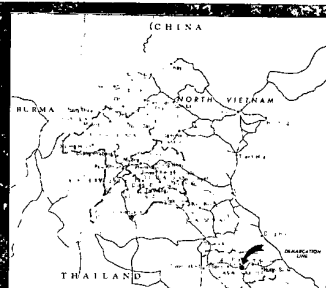
NPIC J-5781 (11/64)

1. [REDACTED] REVEALED A DAMAGED BRIDGE  
ON ROUTE 9 OVER THE SE TA MOK (STREAM) 8 NM NORTHWEST OF MUONG PHINE.  
THE EASTERN PORTION OF THE BRIDGE HAD COLLAPSED AND BRIDGE WAS  
IMPASSABLE TO VEHICULAR TRAFFIC. TWO BOMB CRATERS WERE OBSERVED  
APPROXIMATELY 100 YARDS EAST OF THE BRIDGE.

2. THIS MISSION [REDACTED] REVEALS A  
FOOTBRIDGE AND TWO VEHICLE FORDS (ONE OF WHICH IS COMPOSED OF  
SUBMERGED LOGS) ACROSS THE SE TA MOK SOUTH OF THE DAMAGED BRIDGE. A  
BY-PASS ROAD LINKING THE VEHICLE FORDS WITH ROUTE 9 IS LOCATED  
APPROXIMATELY 450 YARDS WEST OF THE BRIDGE.

3. AN APPARENTLY NEW UNOCCUPIED 4-GUN AUTOMATIC WEAPONS SITE  
(EACH POSITION HAS A PROBABLE AMMUNITION STORAGE BUNKER ADJACENT TO IT)  
WITH TWO ADDITIONAL AW POSITIONS IN CENTER OF SITE IS OBSERVED 500  
YARDS SOUTH-SOUTHEAST OF THE BRIDGE.

4. FIVE ADDITIONAL BOMB CRATERS ARE OBSERVED SINCE PHOTOGRAPHY  
OF [REDACTED] THREE ARE LOCATED IN STREAM BED JUST SOUTH OF LOG  
FORD, ONE IS OBSERVED NEAR SHORELINE, AND THE FIFTH IS LOCATED JUST  
SOUTH OF THE AW SITE.
